Assessment of Photovoltaic Module Failures in the Field

IEA PVPS Task 13, Subtask 3
Report IEA-PVPS T13-09:2017
May 2017

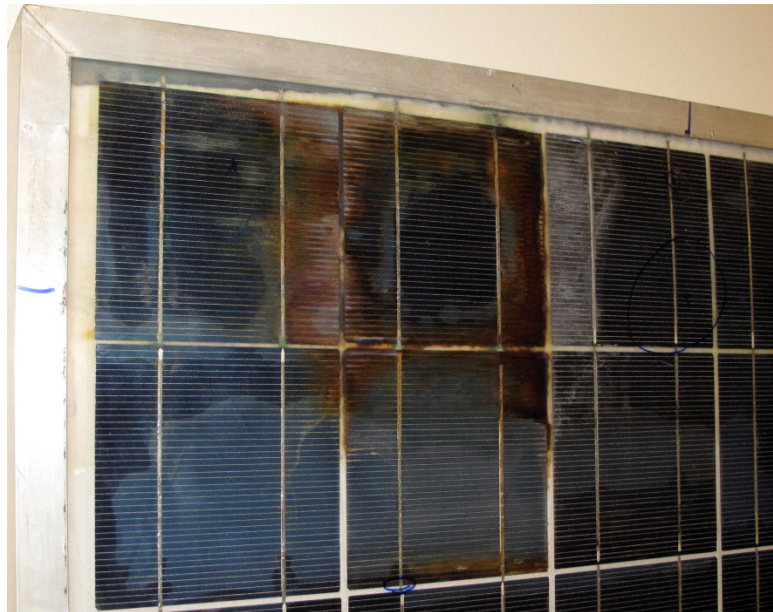
Fig. 4: Glass/glass module with specific ionomer encapsulant type that has proven to have insufficient adhesion, showing delamination and corrosion.

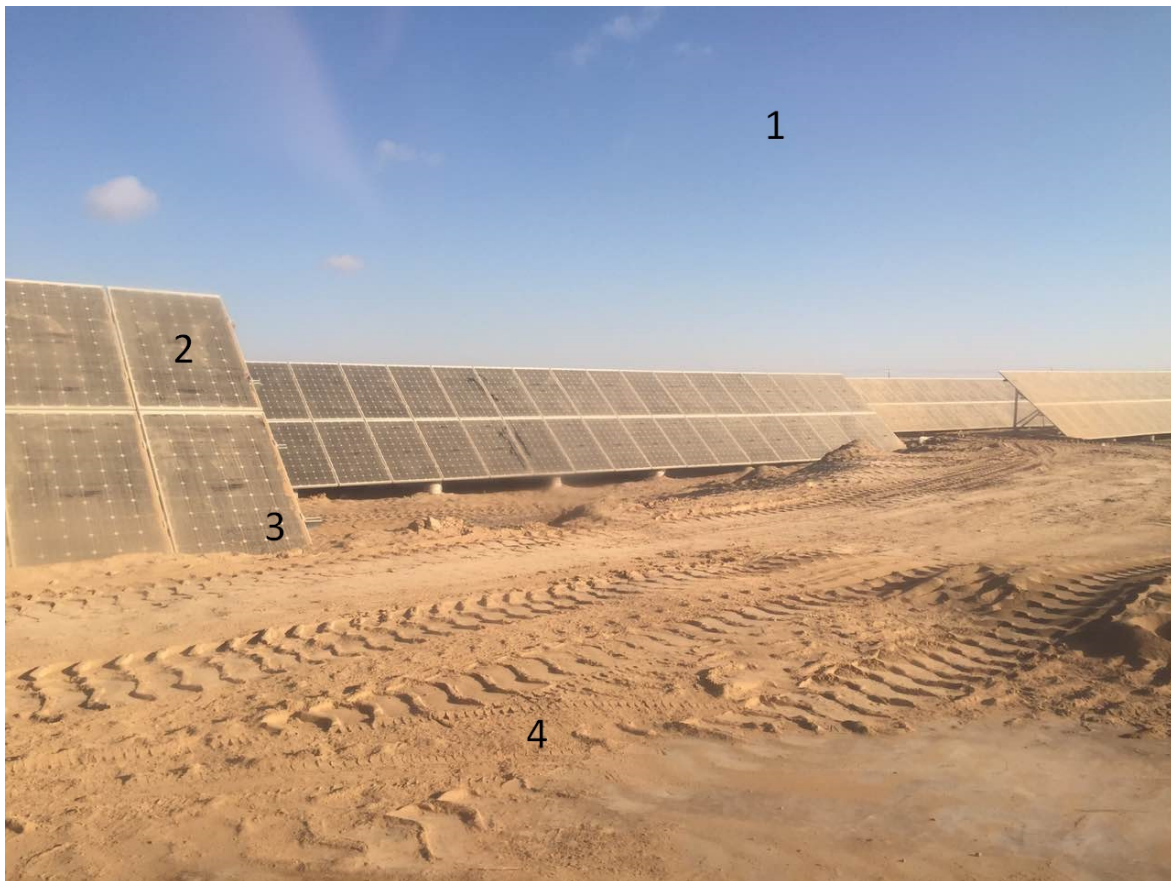
Fig. 32: Factors influencing dust soiling of PV modules in desert regions: 1 Climatic impact, ambient dust concentration, 2 Glazing characteristics, adhesion effects, non-uniform soiling, 3-Installation conditions, 4-Surrounding environment, dust particle characteristics. Photo: TÜV Rheinland Group

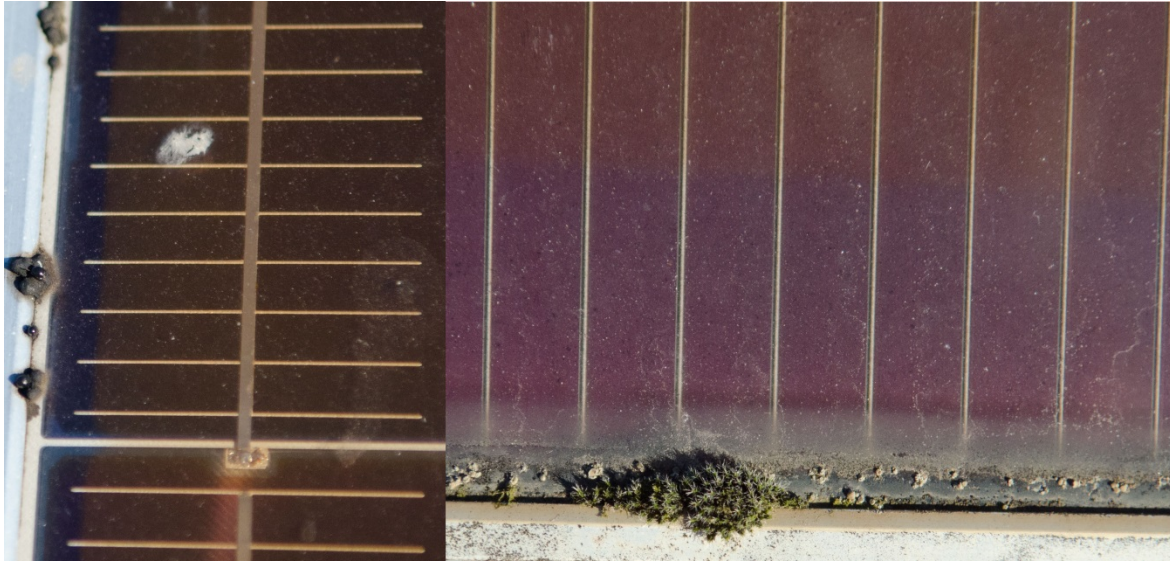
Fig. 38: Example of bird droppings (left) and moss (right) on a PV module.
